Erroneous Flaps selection at RWY holding point

Voluntary Air Safety Report

Flight XYYYYY: FCO – TLV
EOBT – ETA: 11.20 – 14.40 UTC
Trip time: 3^h01^m
TOW: 80.500 kg – Pax 163
Stand: 610
Friday afternoon

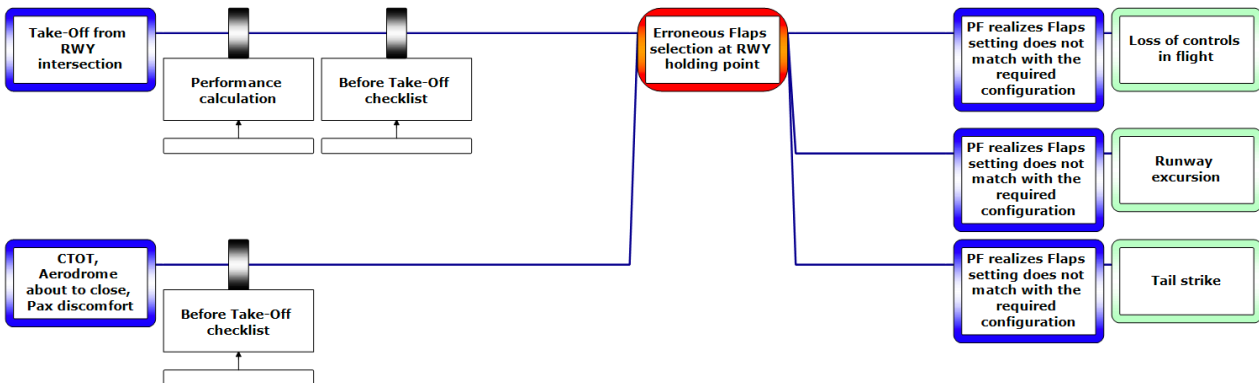
Figure 2: Occurrence analysis

With reference to Figure 2, 2 initiating events have been identified:

1. "Take-off from RWY intersection";
 2. "CTOT, Aerodrome about to close, Pax discomfort";
- which lead to the "Erroneous Flaps selection at RWY holding point" event.

Hence, 3 plausible consequences originate:

1. "Loss of controls in flight";
2. "Runway excursion";
3. "Tail strike";

neutralized by PF intervention who, during line-up, spots Flaps setting required/Flaps lever position mismatch.

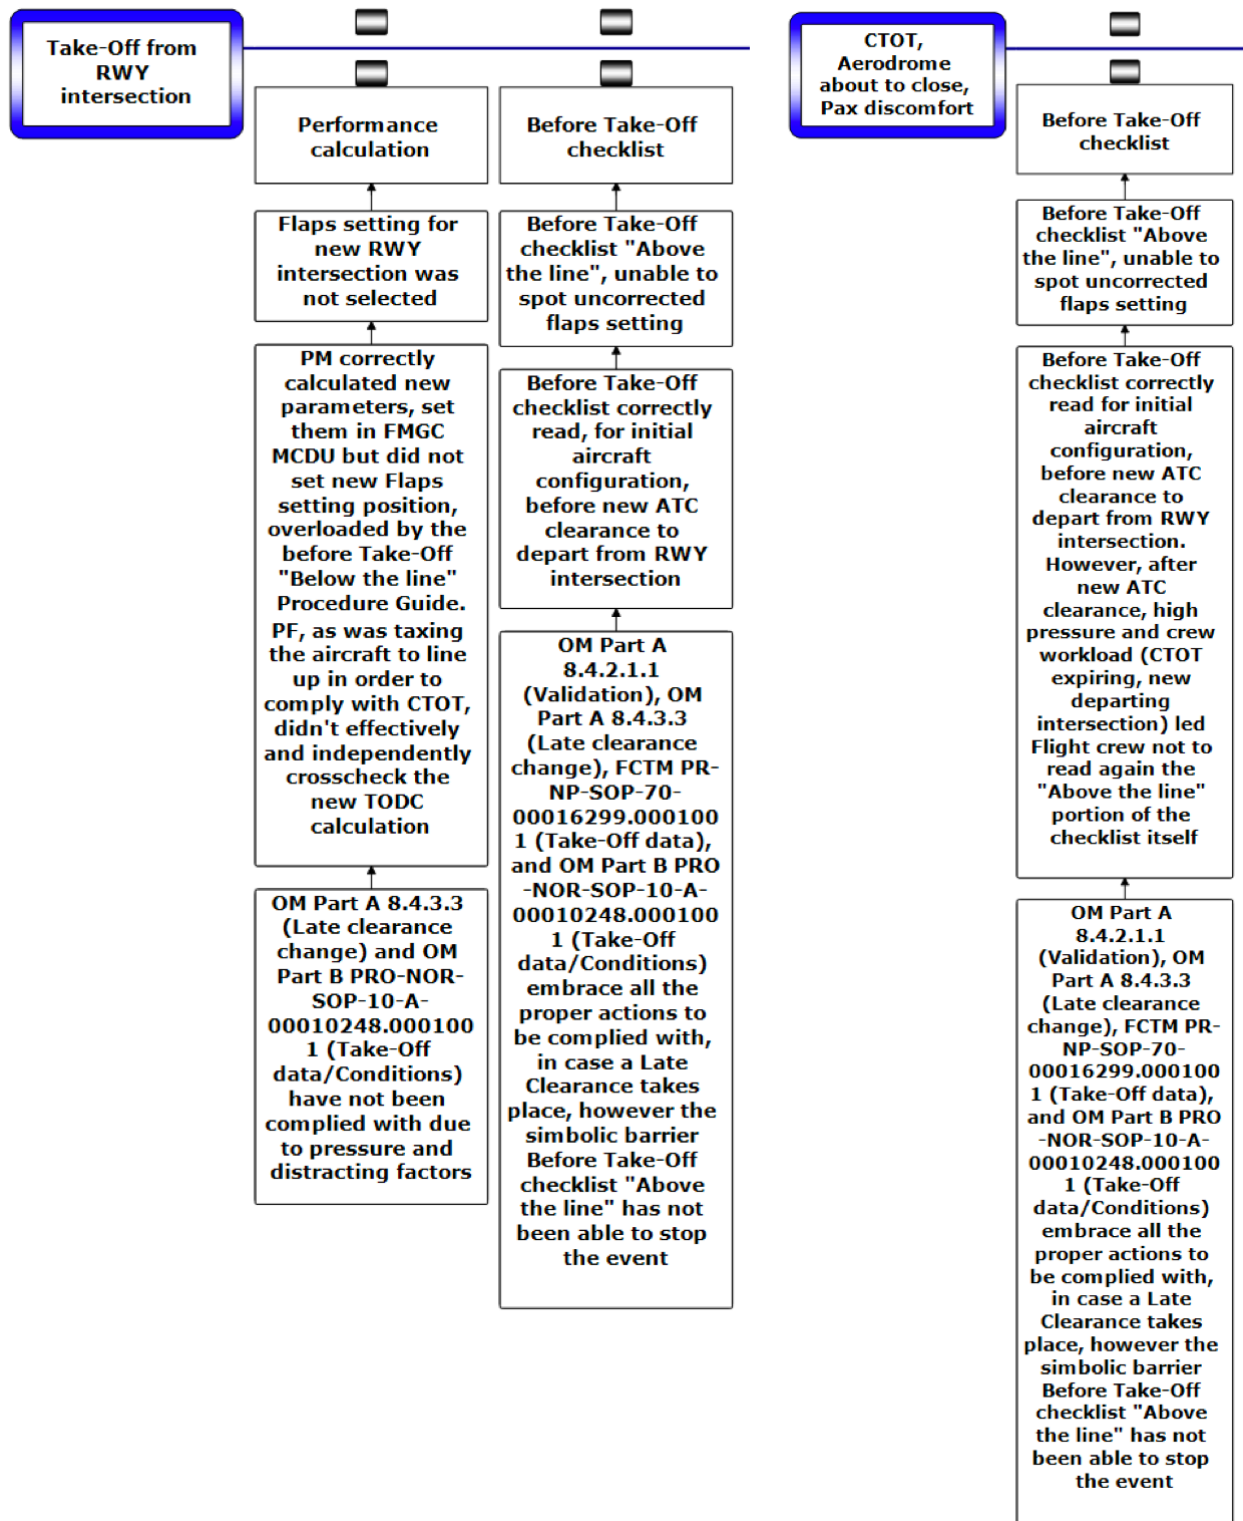
Figure 3: Barrier Failure Analysis (BFA) method for “Performance calculation” and “Before Take-Off checklist” barriers

BFA method (Barrier Failure Analysis) to in-deep barriers status understanding shall be used (Figure 3) for our occurrence analysis.

This method (3 blocks method), consists in the research of underlying causes linked to the three following questions: WHAT happened, WHY did it happen, HOW did it happen (last one cause, to be looked for, at higher organizational level). Following this approach, the condition of “Failed” for “Performance calculation” and “Before Take-Off checklist” barriers can be worked out.

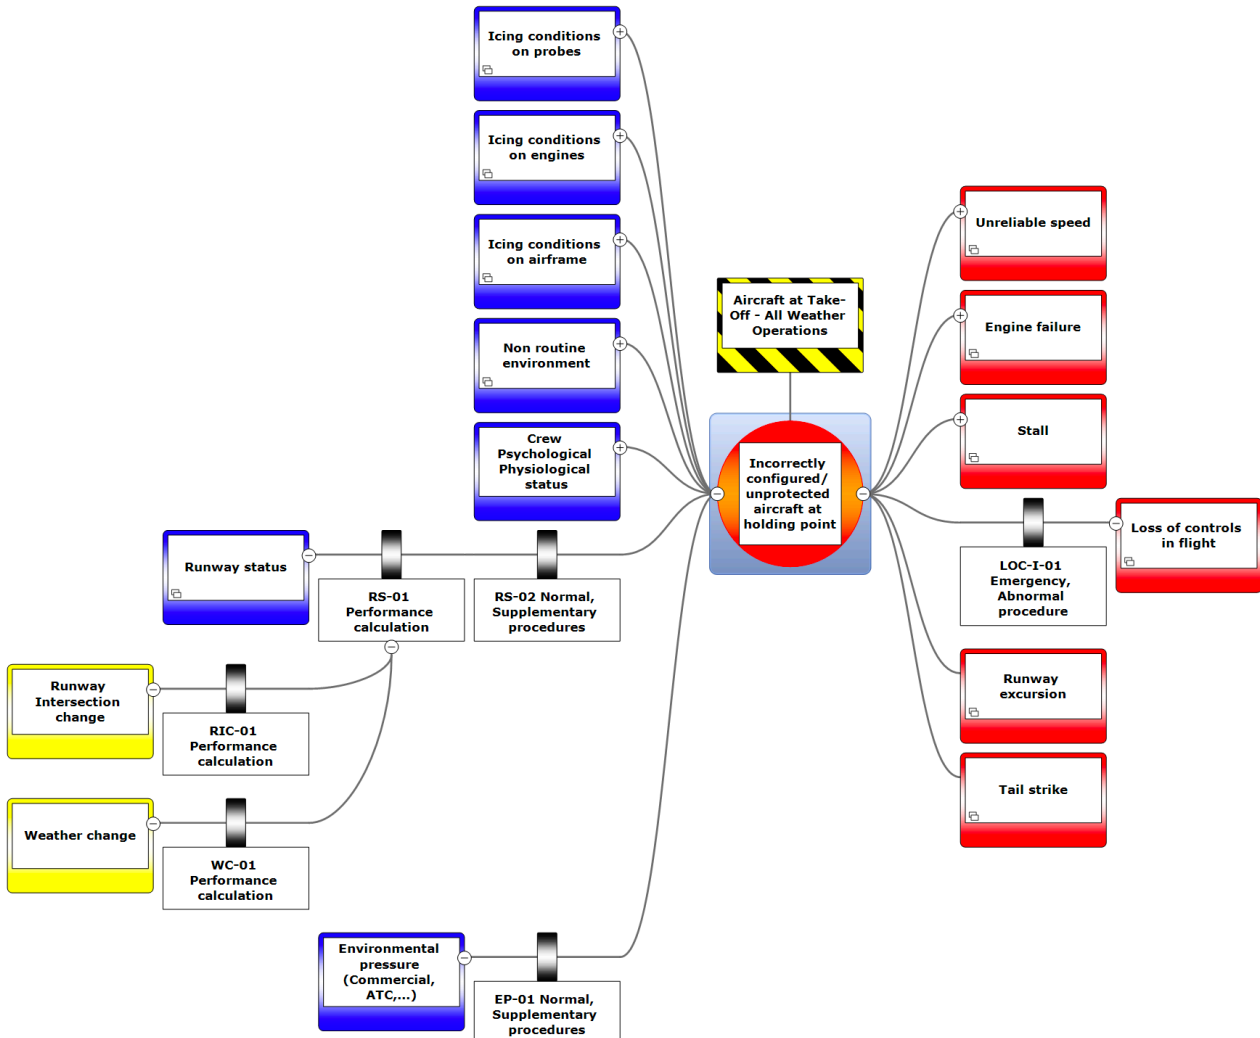
Figure 4: Bow-Tie visual risk assessment, Aircraft at Take-Off – All Weather Operations

Let's now look at the occurrence within a wider and all-embracing risk analysis context, which approaches the Hazard "Aircraft at Take-Off – All Weather Operations" leading to an associated Top Event "Incorrectly configured/unprotected aircraft at holding point" (Figure 4).

"Runway status", "Environmental pressure (Commercial, ATC, ...)" threats and "Loss of controls in flight", "Runway excursion", "Tail strike" consequences are the only limbs enlarged for the purpose of present analysis. Left of Top Event, the last two of seven threats, "Runway status" and "Environmental pressure (Commercial, ATC, ...)" are exactly parents of our occurrence initiating events. Right of Top Event, the last three of six consequences are exactly our proposed outcomes. Moreover, RS-01 barrier is strictly influenced by two escalating factors, the first of those, "Runway Intersection change" (occurred to flight crew), pierced through a failed mitigating barrier "RIC-01 Performance calculation". It is worth noting that no mitigating barriers are in place on the last two consequential limbs "Runway excursion", "Tail strike".

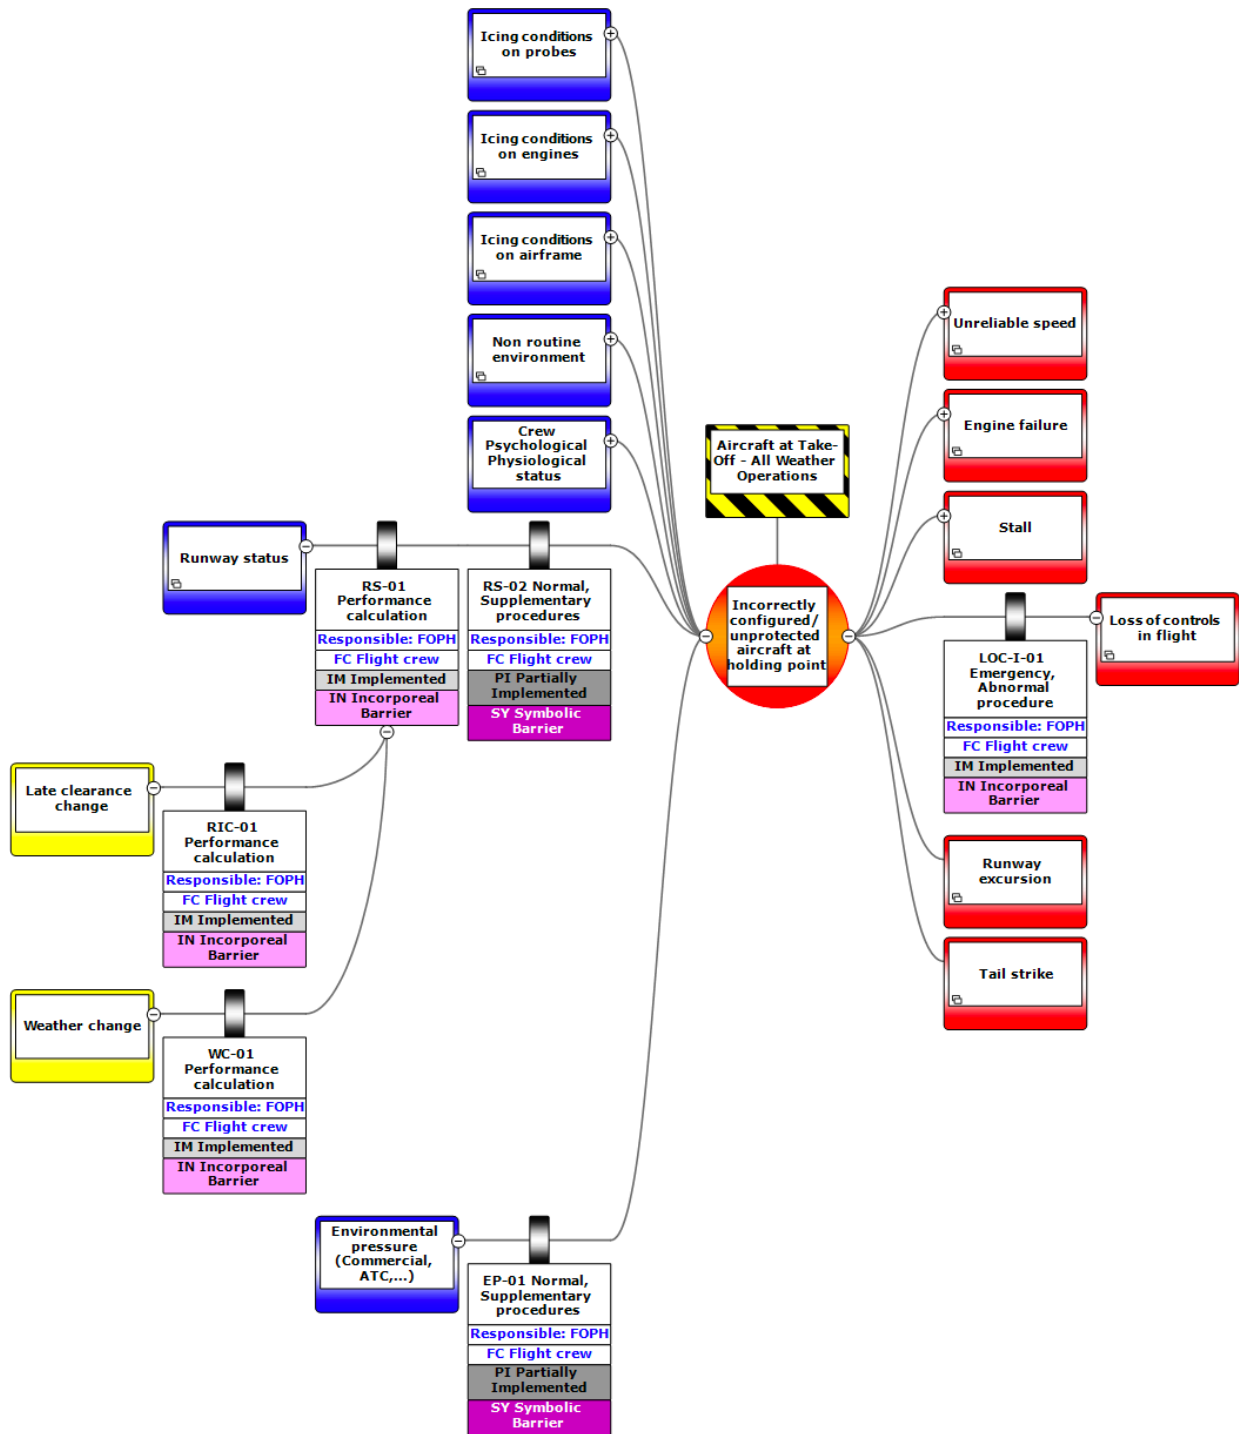
Figure 5: Barrier description

Enlarging barriers RS-01, RS-02, RIC-01, WC-01, EP-01 e LOC-I-01 the following can be inferred (Figure 5):

- Responsibility:** All barriers report to Flight Operations;
- Accountability:** Flight Crew are the only direct actors interfacing with all barriers;
- Implementation:** RS-02 and EP-01 have new software FWC-H2F9D (see next page) at implementing stage, but only on some fleet aircraft (this is the reason of Partially Implemented barrier indicated);
- Nature:** RS-01, RIC-01, WC-01 and LOC-I-01 are Incorporeal barriers: RS-02, EP-01 only Symbolic.

2. FWC-H2F9D¹ software implementation certainly mitigates the frequency of similar occurrences, since it introduces a partially Functional interface, however it cannot prevent occurrences belonging to the following scenario: Flight Crew omits either the insertion of new FMGC-MCDU Flaps setting and the selection of corresponding Flaps lever, in response of a triggered new departure configuration change.

3. Human Factor wise, an effective and inexpensive counter measure (without any Regulator actor involvement) which should lead to a further frequency mitigation could be adopted with the following two steps:

- a. The reading of the Before Take-Off checklist "Above the line", shall be postponed at the holding point, aircraft on parking brake and only after having implemented all modifications for new TODC related to Runway departing position and Weather change.
Moving as close as possible to the Top Event the most powerful barriers in place (Symbolic RS-02, EP-01 as neither Functional nor Physical exist) can be the an immediate effective countermeasure.

- b. During such reading and only after having complied with "FCTM PR-NP-SOP-70-00016299.0001001 (Take-Off data)" and "OM Part B PRO-NOR-SOP-10-A-00010248.0001001 (Take-Off data/Conditions)" PM challenges Take-Off Data Card (Speeds, Flaps e Flex) physically keeping in hand TODC, while PF responding and visually checking in FMGC-MCDU Performance page and Flap Indication/Lever.
