Erroneous Flaps selection at RWY holding point

Voluntary Air Safety Report

Flight XYYYYY: FCO – TLV
EOBT – ETA: 11.20 – 14.40 UTC
Trip time: 3^h01^m
TOW: 80.500 kg – Pax 163
Stand: 610
Friday afternoon

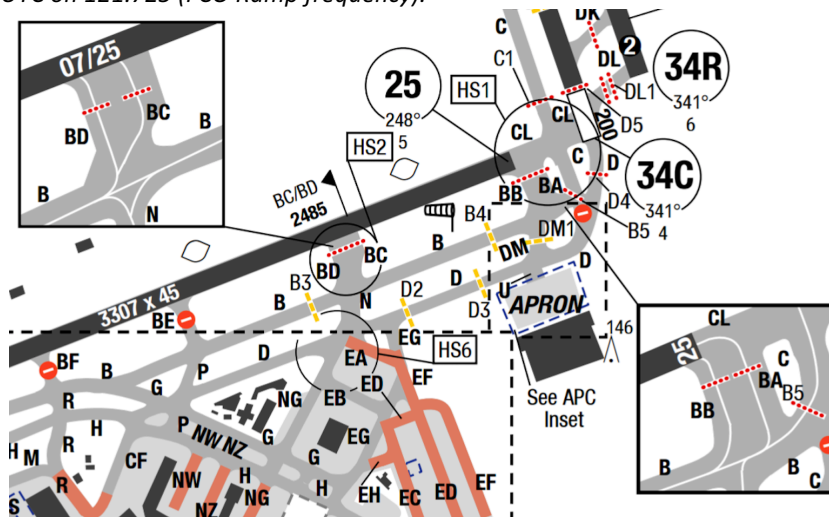
Figure 1: Airport Ground Chart

Before taxing Flaps 1+F were selected as per TODC (Take-Off Data Card) RWY 25 R01 (Full length) and aircraft was instructed by 122.125 (FCO Ground West) to proceed via R-B holding short N (Figure 1), for ground frequency change (2 engine Taxi due weight). During taxi PM (Pilot Monitoring) suggested to get TODC RWY 25 T01 (BC intersection) ready for use. Both crews agreed on the issue and PM printed out new TODC for T01. On main taxiway B, crew realized for about 5 traffic taxiing ahead of them on N, and decided to slow down abeam BC intersection despite instructed, by 121.9 (FCO Ground East frequency), to proceed full length and monitor Tower frequency 118.7. Before Take-Off checklist down to the line was completed. Time is now around 11.50 UTC.

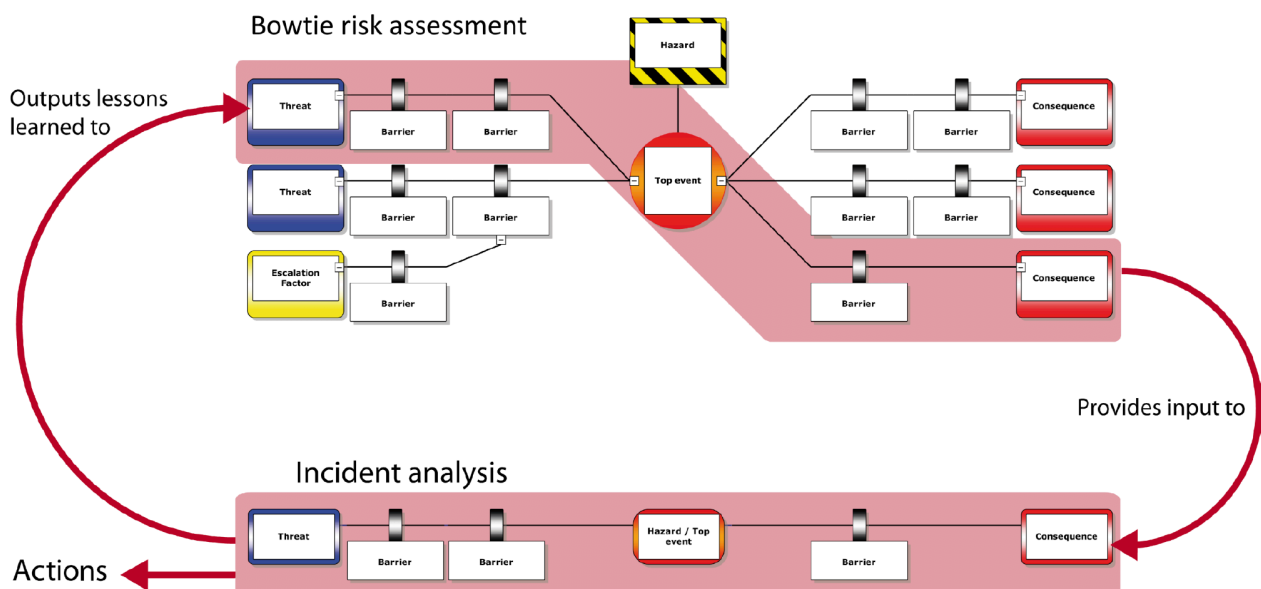
Figure 3: Barrier Failure Analysis (BFA) method for “Performance calculation” and “Before Take-Off checklist” barriers

BFA method (Barrier Failure Analysis) to in-deep barriers status understanding shall be used (Figure 3) for our occurrence analysis.

This method (3 blocks method), consists in the research of underlying causes linked to the three following questions: WHAT happened, WHY did it happen, HOW did it happen (last one cause, to be looked for, at higher organizational level). Following this approach, the condition of “Failed” for “Performance calculation” and “Before Take-Off checklist” barriers can be worked out.
